# Pedestrian Safety Program at Michigan State University

# Campus Wide Results

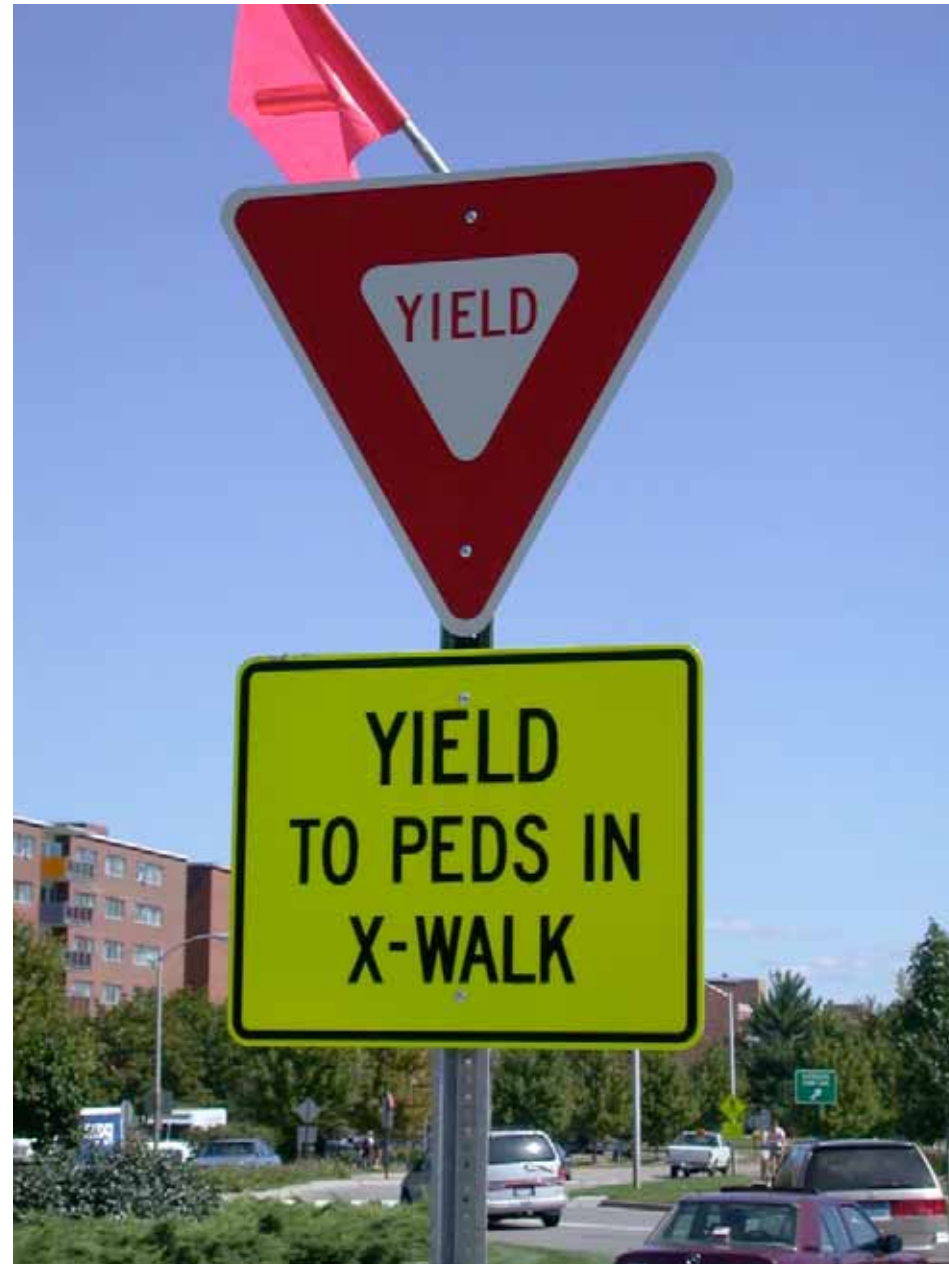
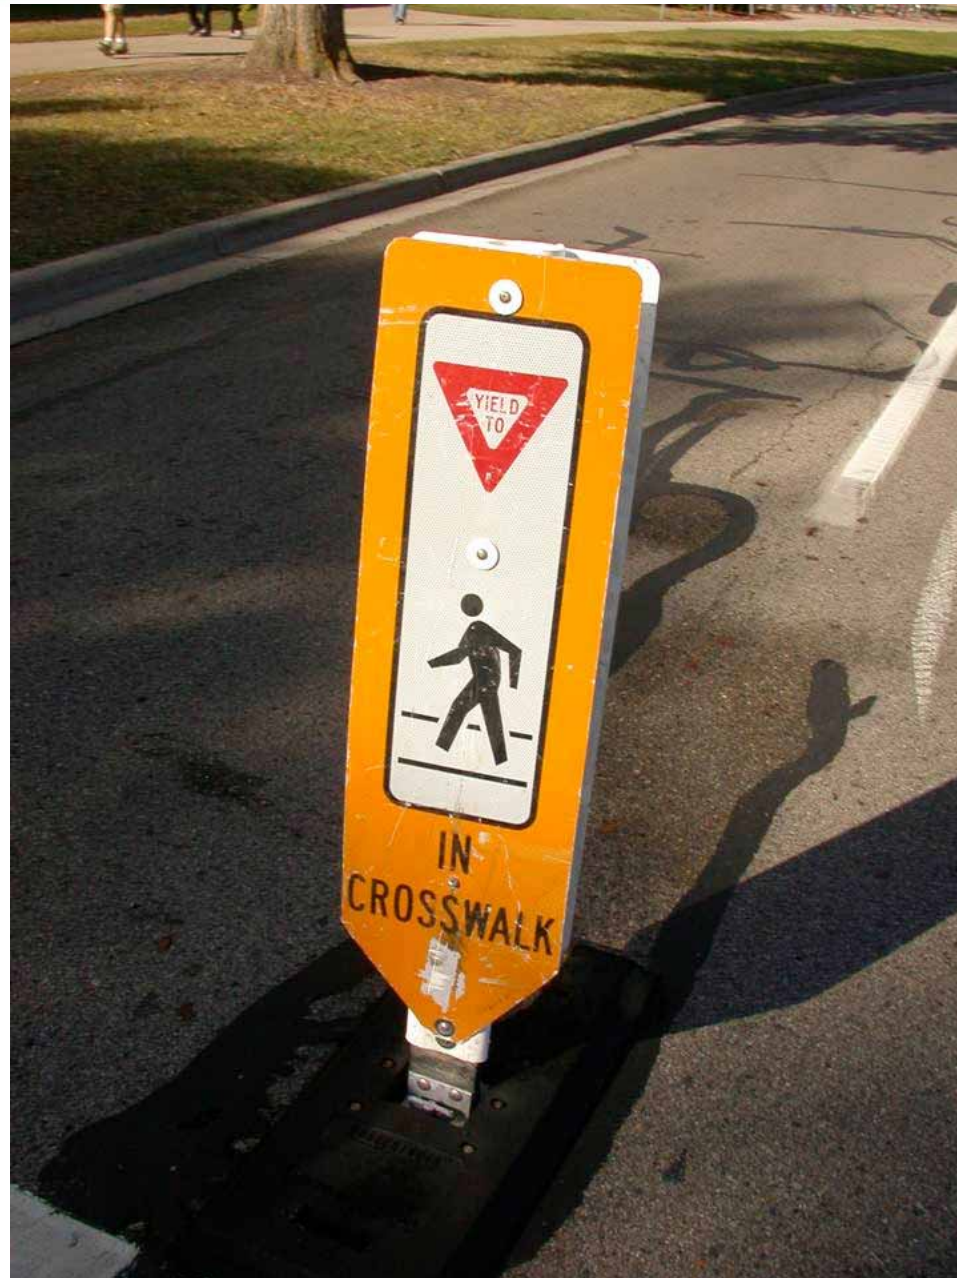
# Traffic signs

Bottom height  
Location  
Specially fabricated

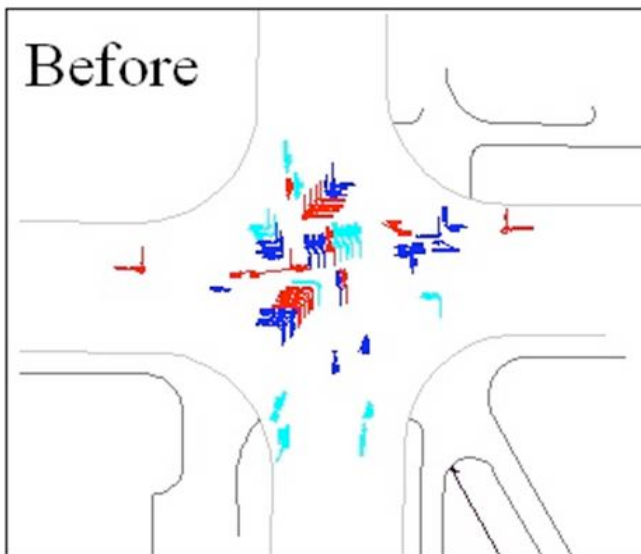
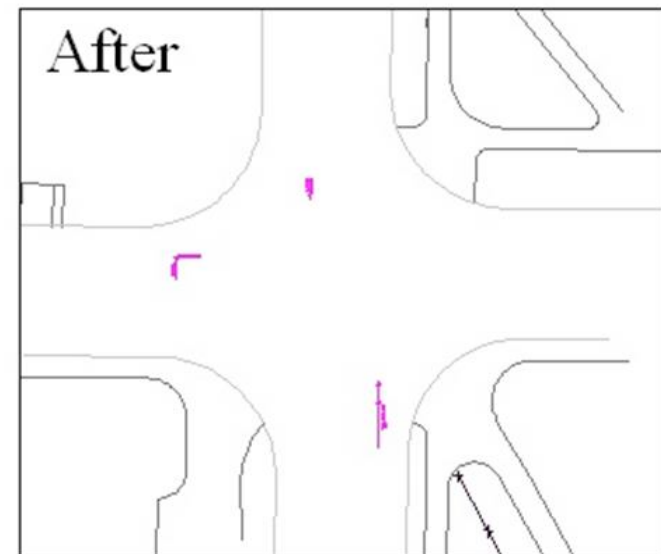
## Traffic Accidents at Auditorium and Farm Lane Intersection before and after traffic signal installation

**Before**

**After**

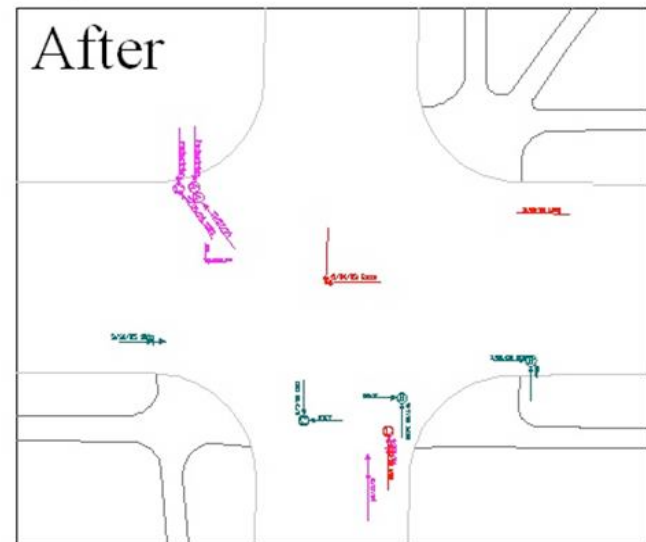
## Traffic Accidents at Wilson and Farm Lane Intersection before and after traffic signal installation

**Before**

**After**
